Are trees able to live and develop within a rock based substrate?

"Trees Rock in Rock"

Webb Conference
May 18th 2011

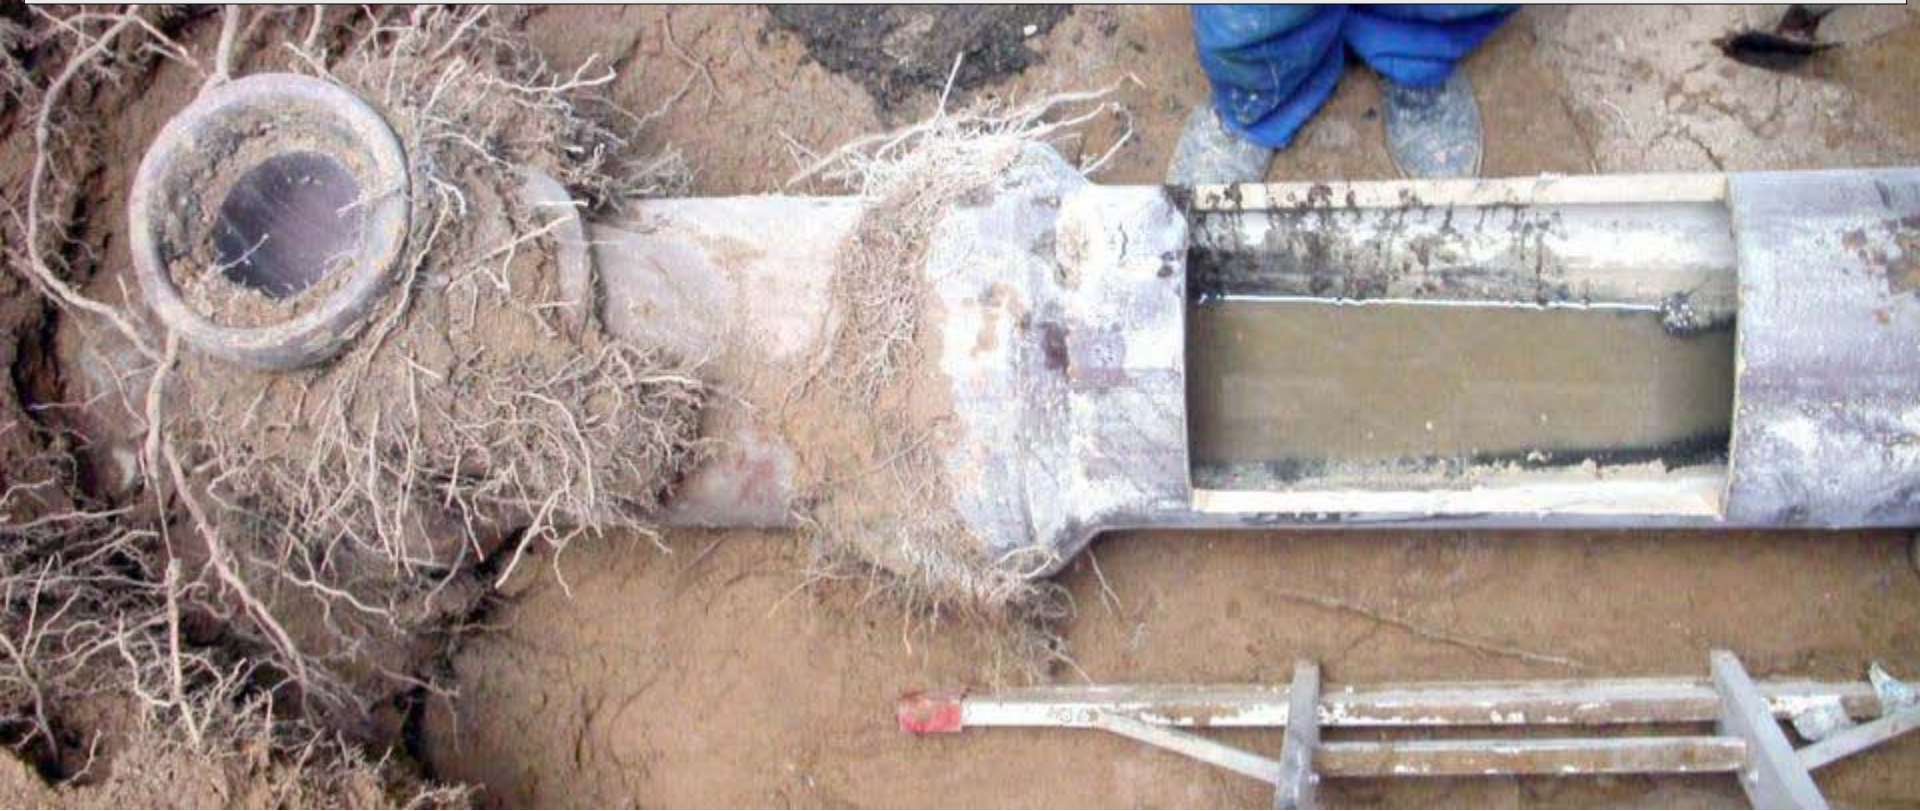
Twenty years of experiences studying root intrusion problems in sewer pipes

Massive root develop in the pipe and pipe trench at a depths of 9 feet

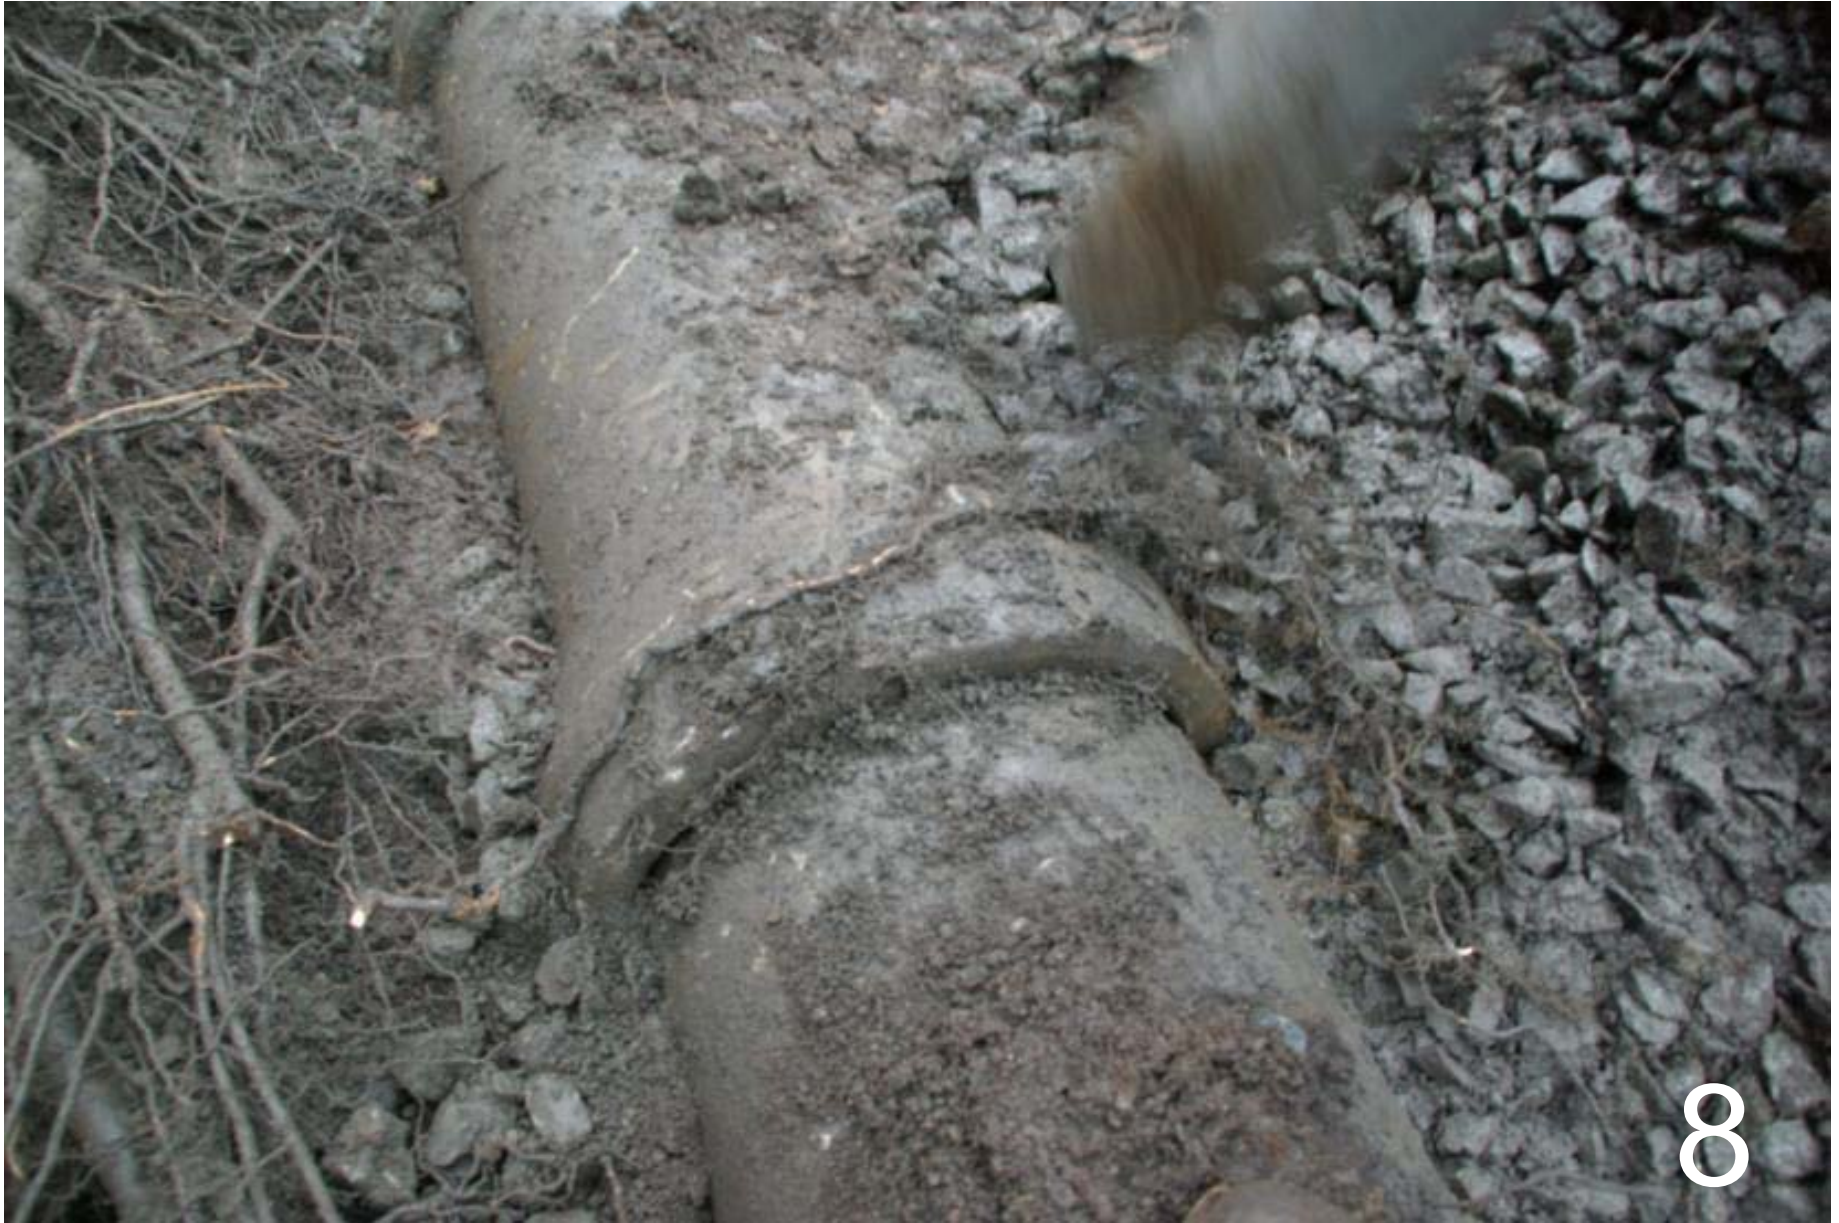
Massive amount of roots in a railway embankment, Stockholm Sweden.

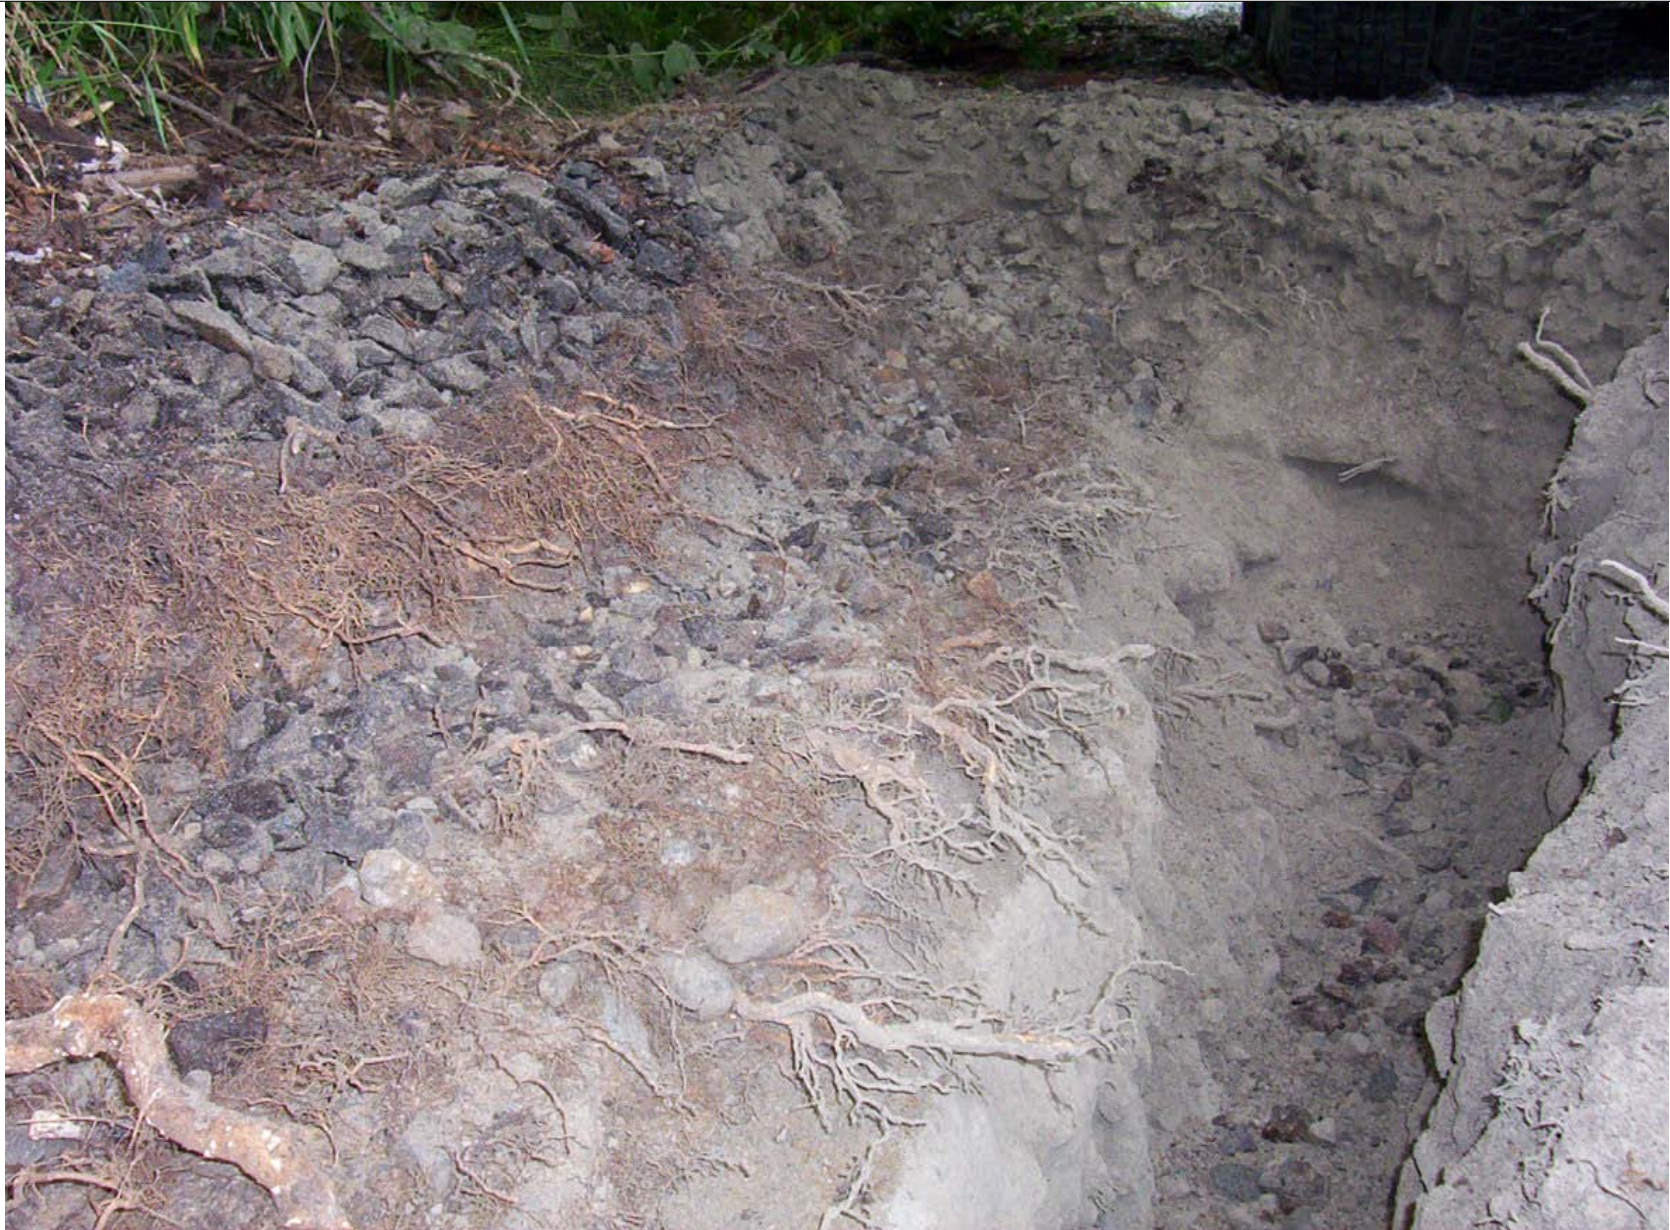
Massive amount of roots in cable covers for electrical wires, Stockholm Sweden.

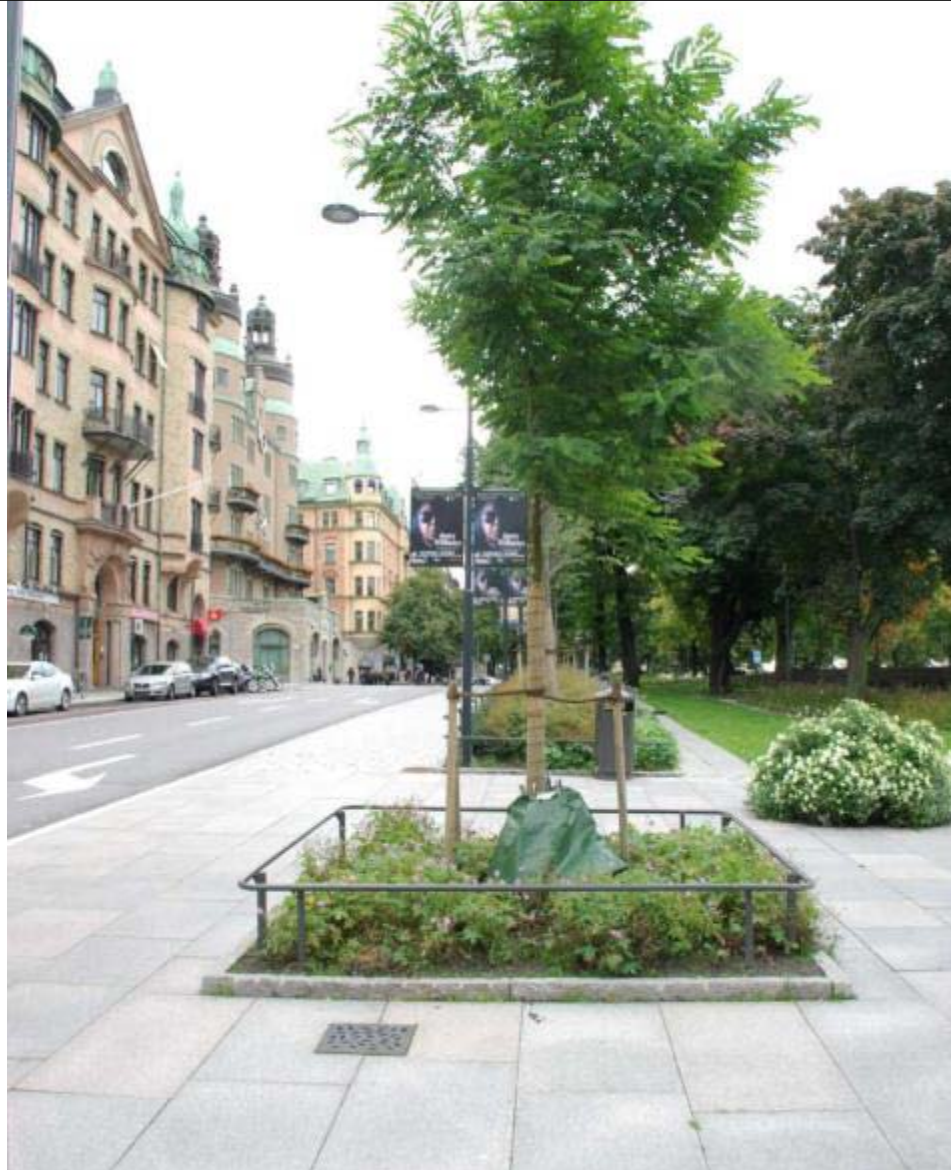
The extension of roots in the airy layer of rocks are approx. one yard per year in the pure rock layer!

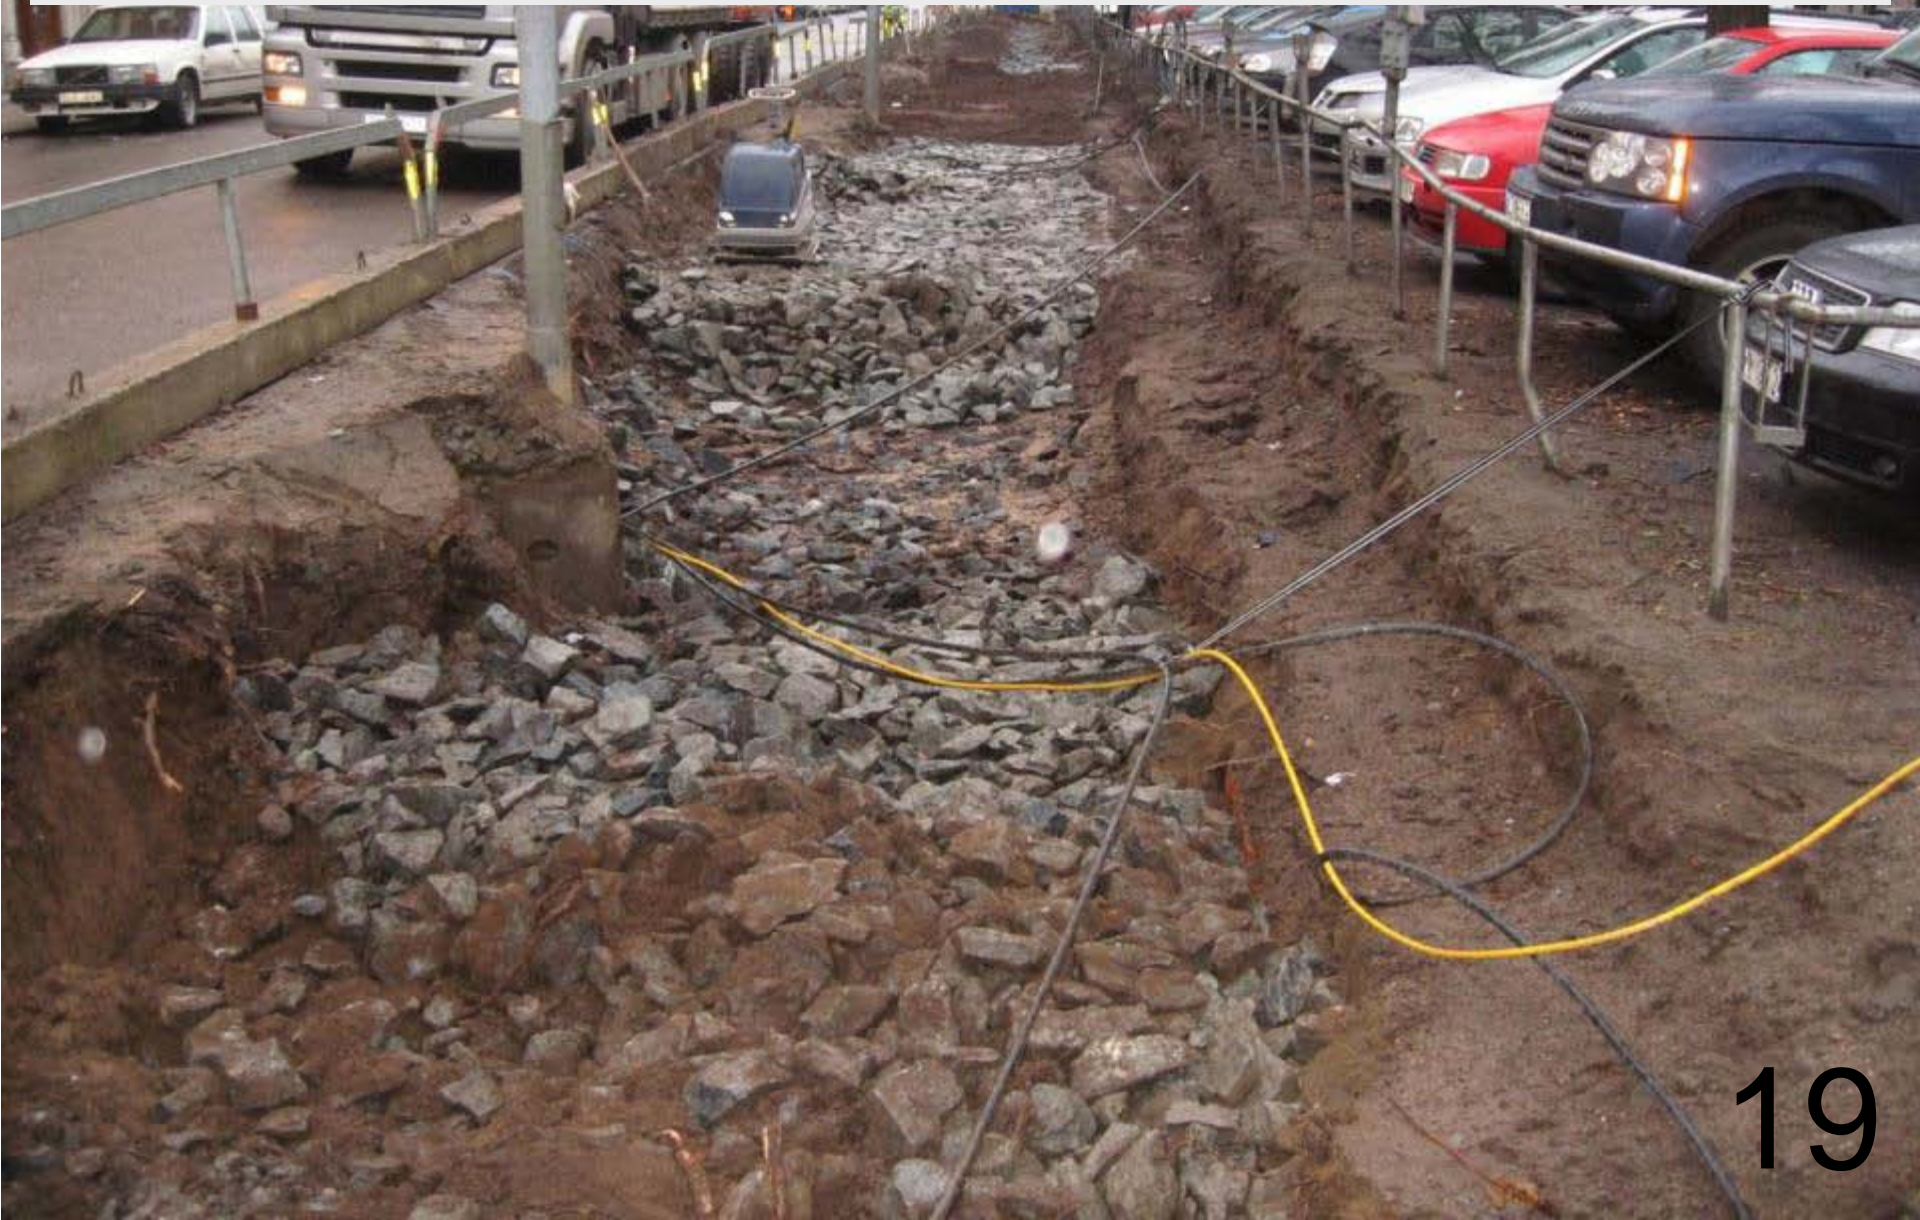
Soil only where the root ball will be placed. The rest of the ground filling is rocks in different fractions.

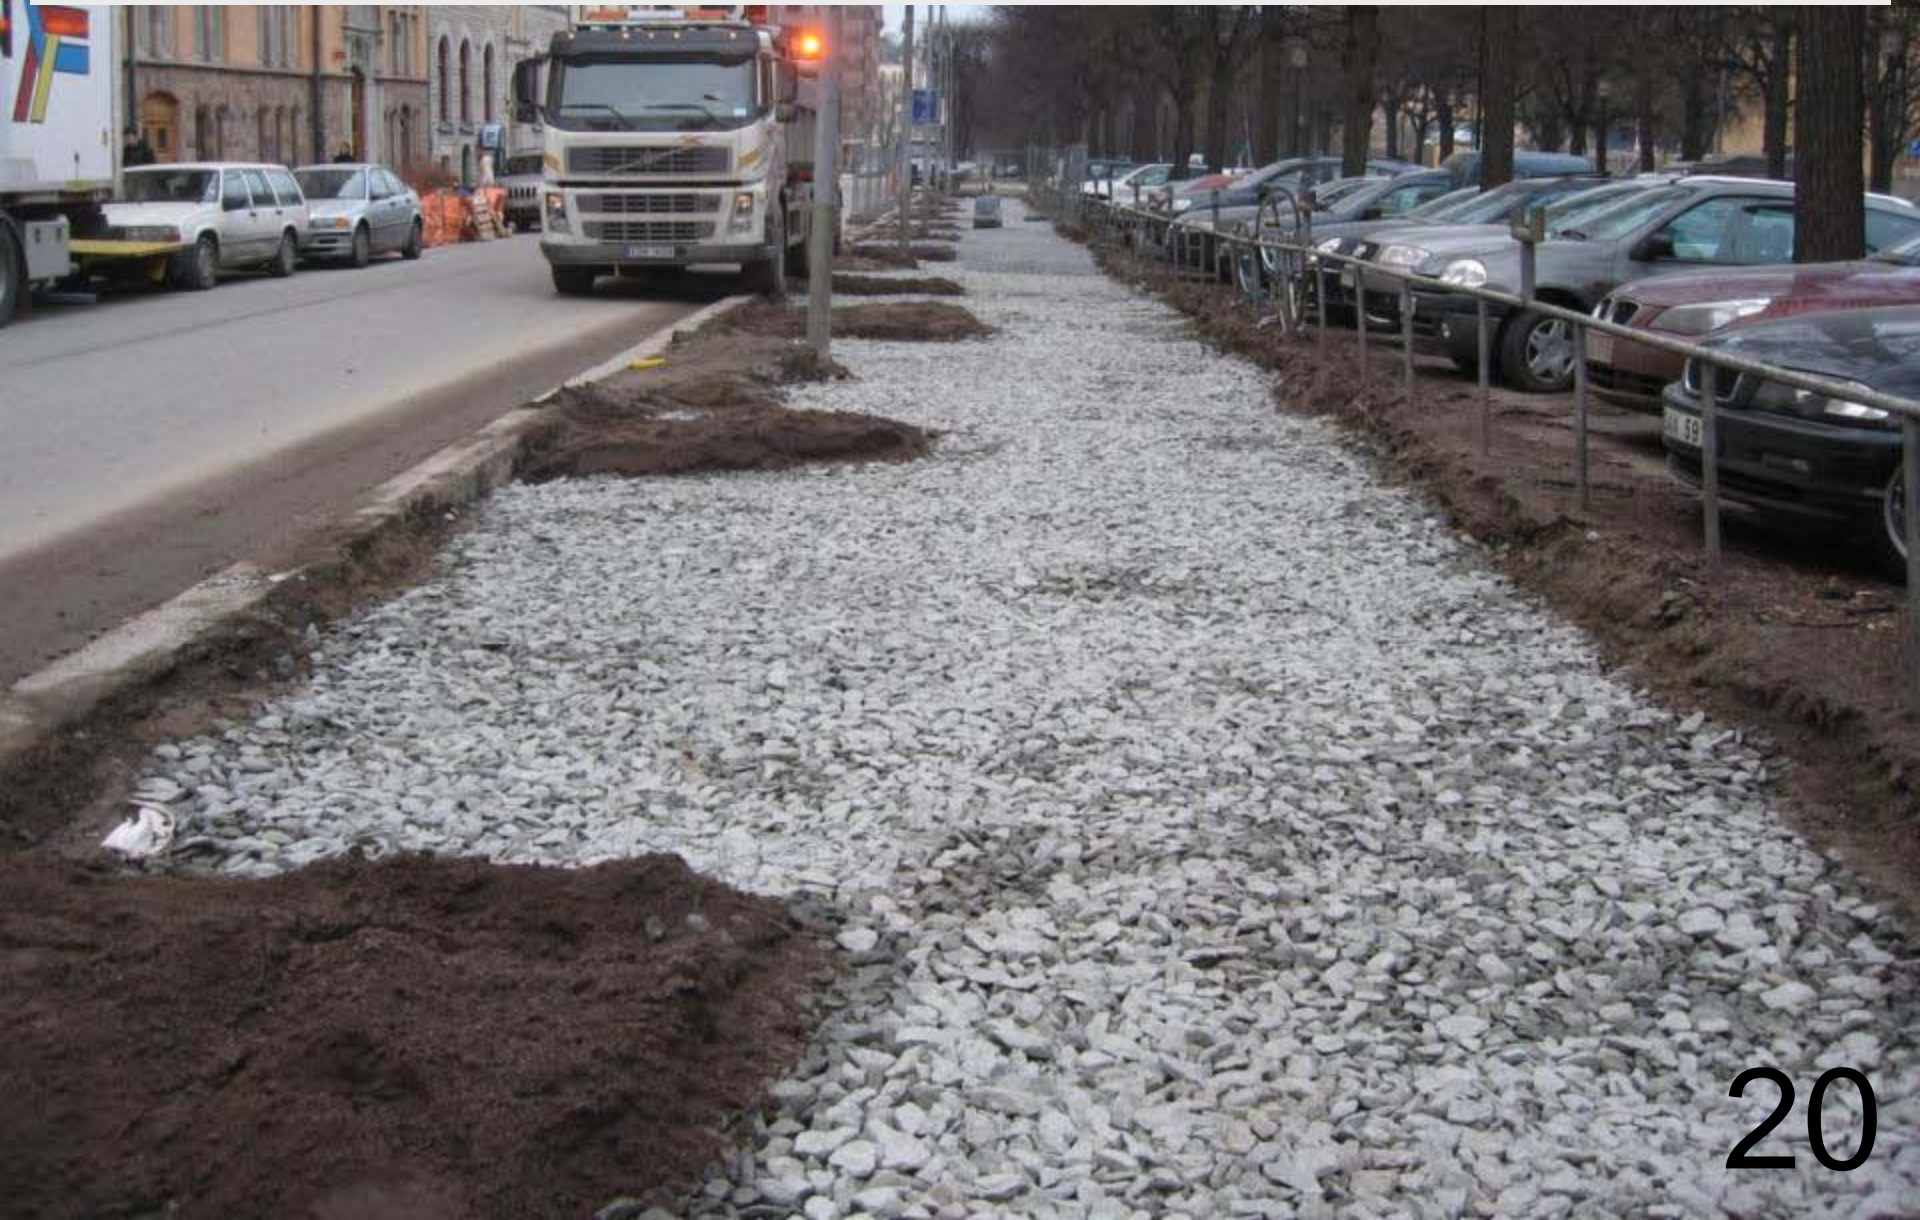
Infiltration capacity 1,969 inches /hour!!

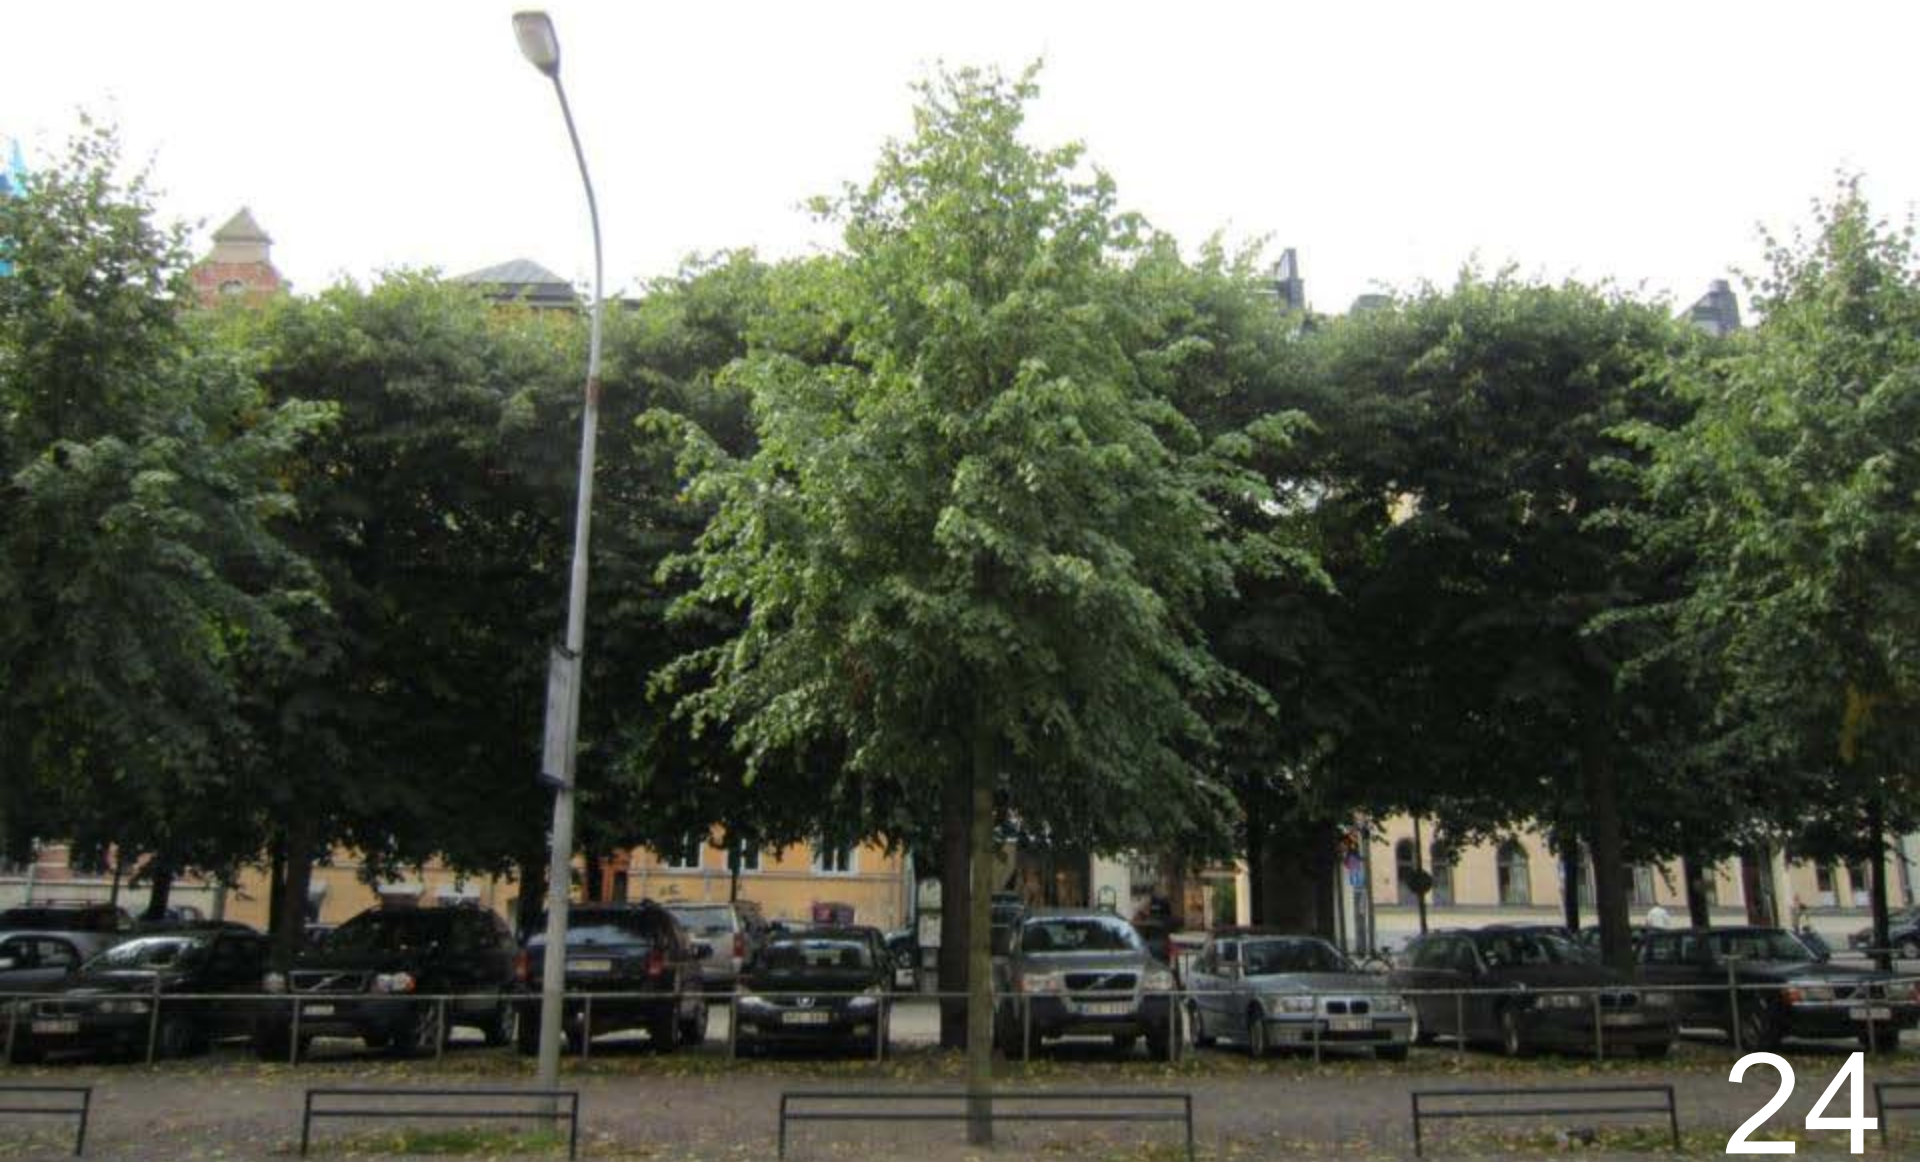
The growth of branch shoots are approx. 16 – 20 inches per year

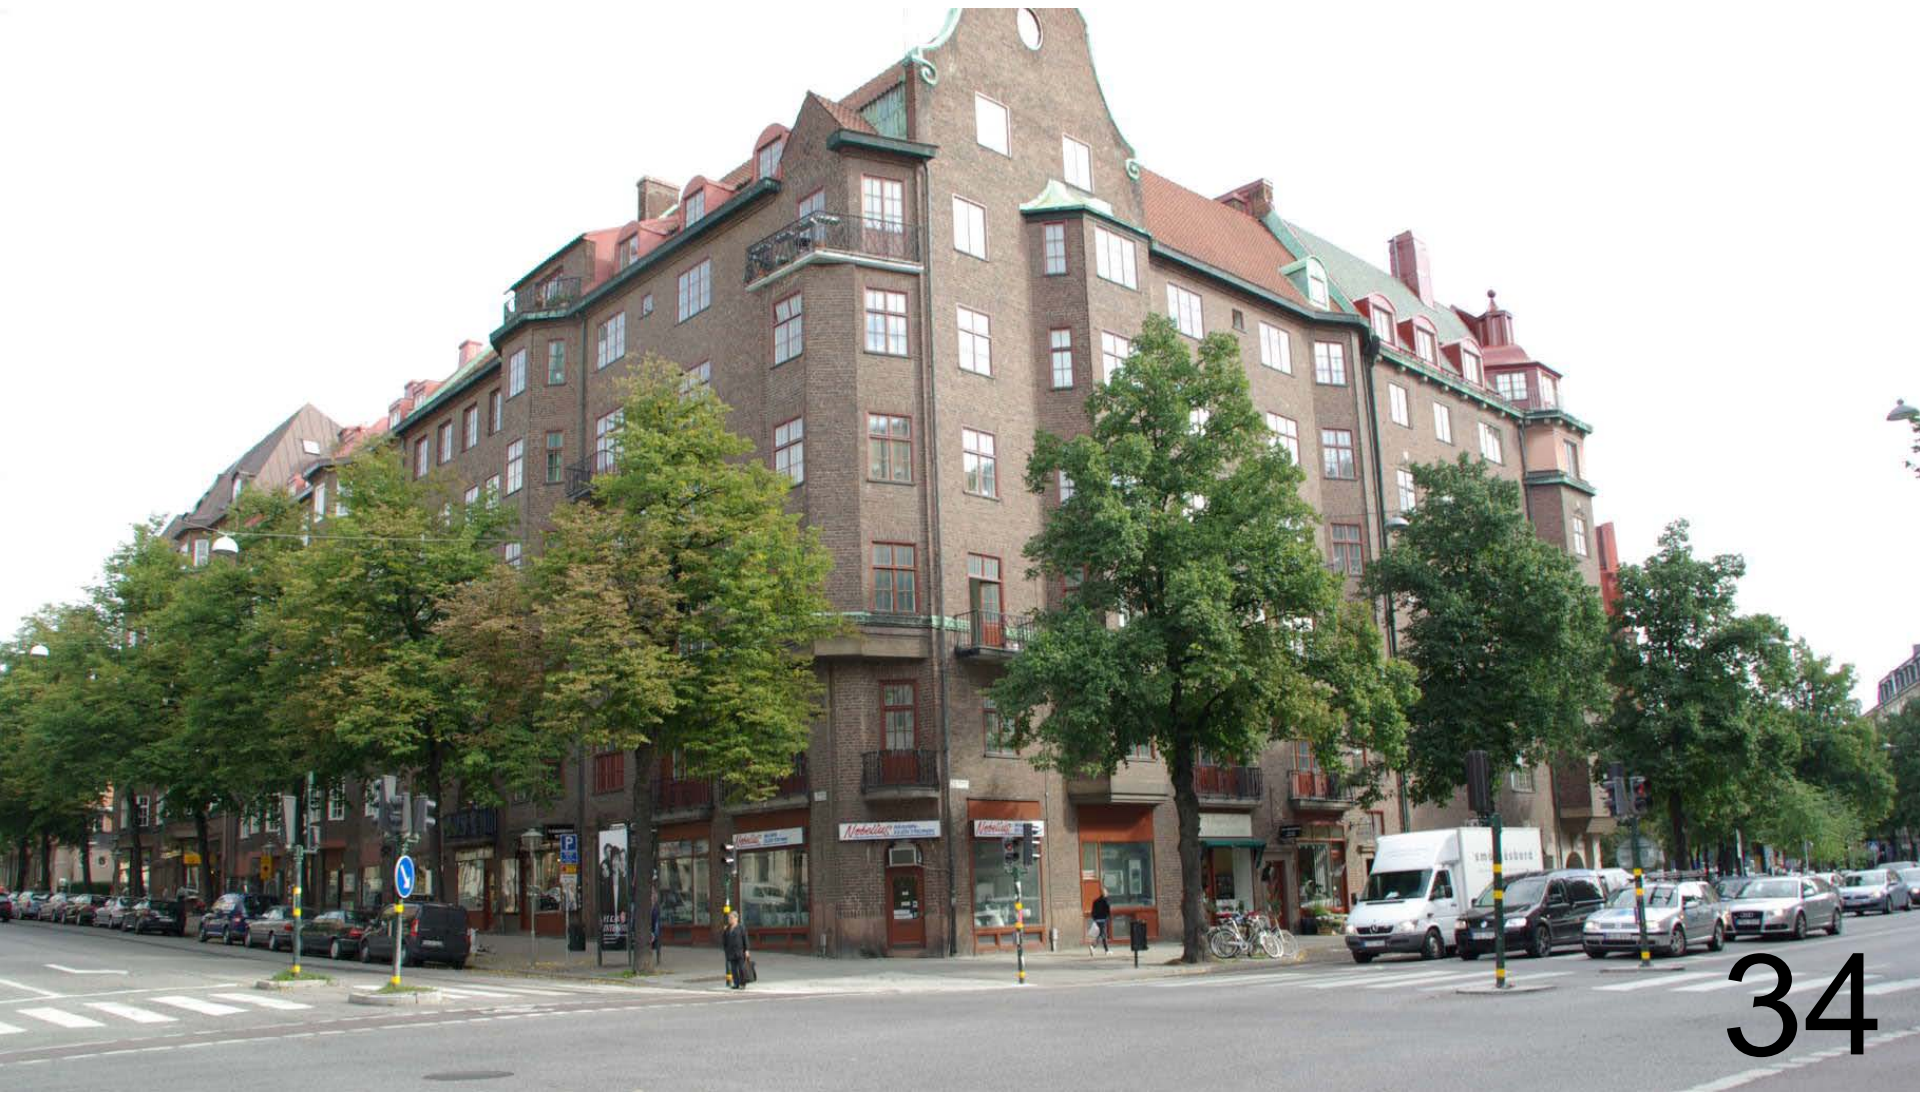
Results after four years after vitalization on mature trees, left trees untreated right trees treated

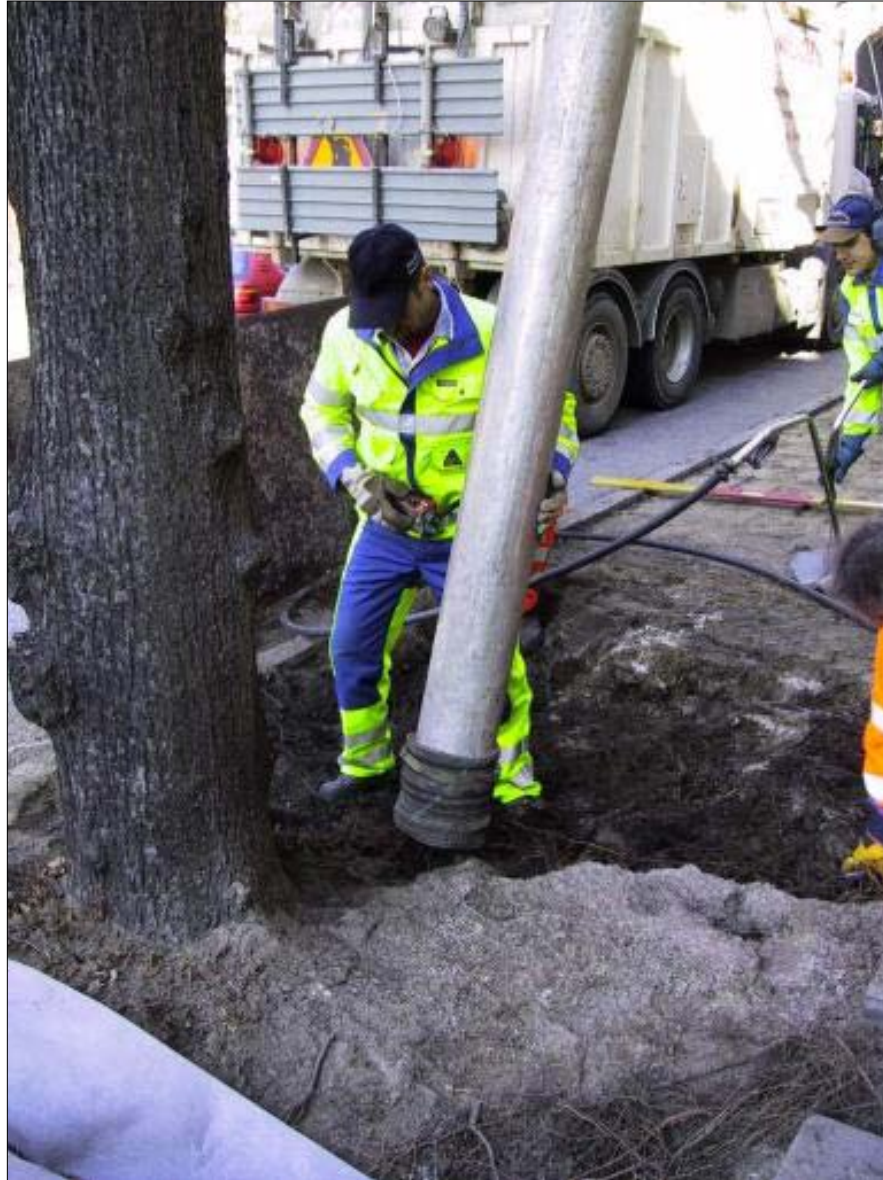
Vacuum exuviations within the root zone

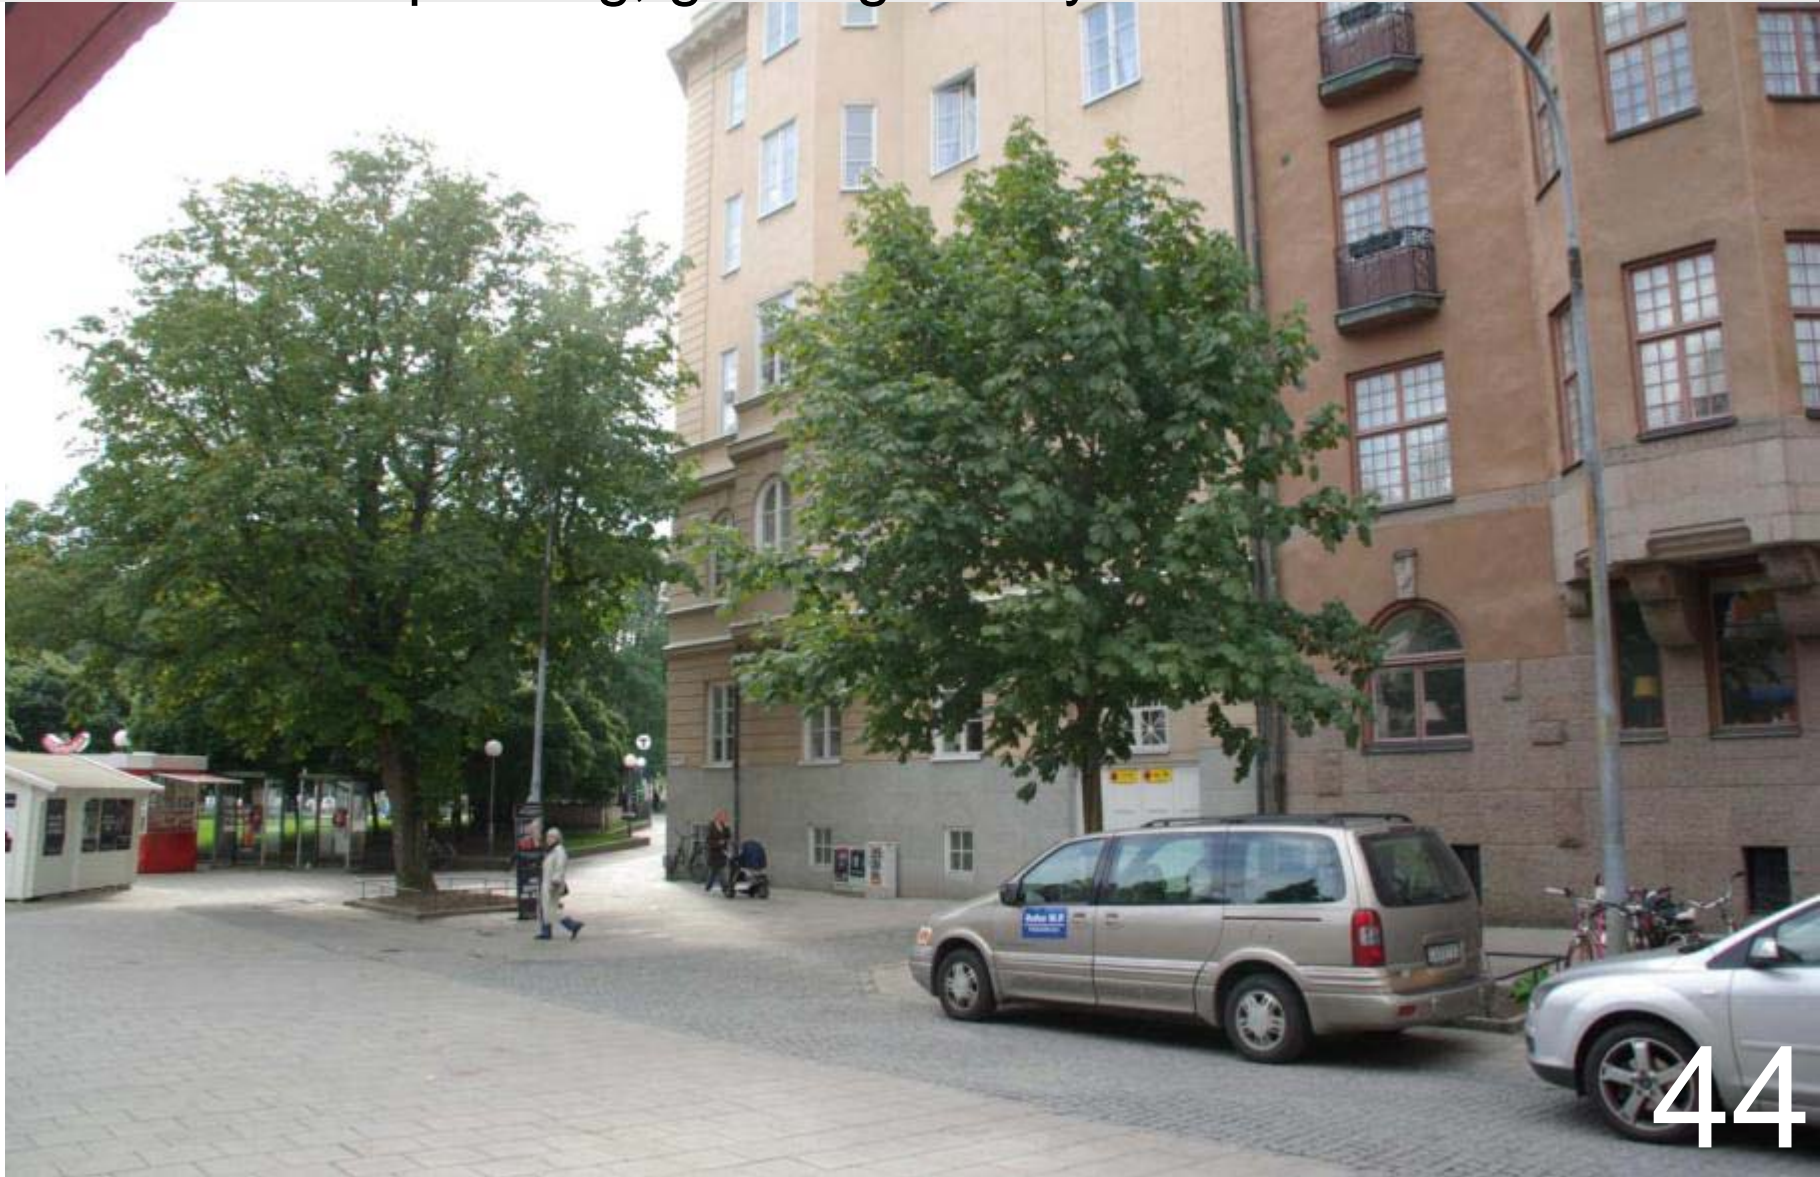
Tree at the left are the original tree approx. 100 years old.
Tree at the right planted in size of 13 – 15 inches, six year after
planting, growing mostly in rocks!!
